Test & Itchen River Restoration Strategy - Appendix B Progress Report

River (& local name)	Reach Code	SSSI Units	Management Option
River Test – Wherwell Estate	T053	87	Rehabilitate
<p>SU 39874 41368 (middle of site main river)</p> <p>Restoration Potential- Issues to address in Appendix B of the strategy:</p> <p>Local enhancement works have already been undertaken here through pool excavation and bed re-profiling. The banks are fenced along both banks. Margins are mown. Reach has a high flow diversity through enhancement works to create a dominance of pools.</p>			
<p>Restoration actions in Appendix B of the Strategy:</p> <p>Rehabilitate channel through:</p> <ul style="list-style-type: none"> - Riparian planting - Bed level raising - Vegetation management through reduced mowing/cutting regime allowing margins to develop. - Reduce dredging 			
<p>Restoration actions carried out:</p> <p>These works were carried out by Robert Bull in the autumn of 2017. The above 'Restoration Potential' paints a better picture than what was actually there. The channel had been dredged in numerous places and had few real features. To improve things a variety of restoration techniques were used over a l

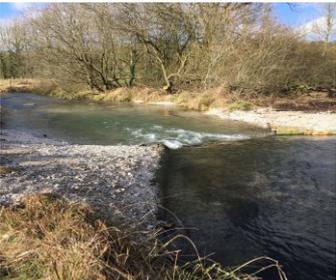
<p>New pinch point on larger channel looking downstream.</p>

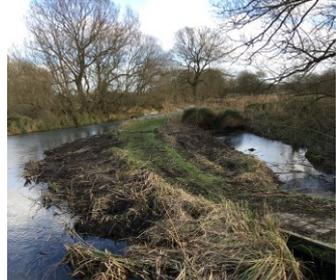
<p>Improved meander with new backwater habitat created.</p>
