JBA
consulting

River Blythe Restoration Plan

Draft for comment

May 2017

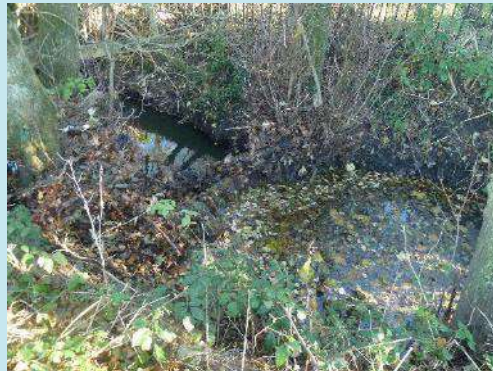
<p>Example natural dam formed from large woody material and leaf litter, creating flow variation.</p>

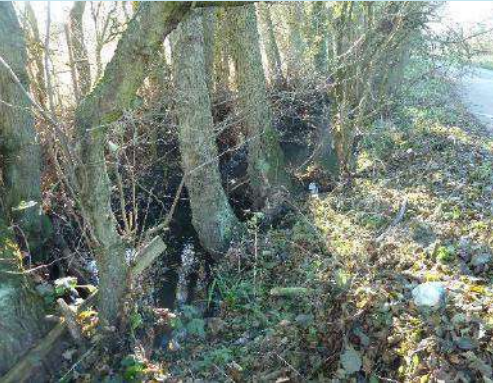
<p>Uniform channel width of approximately 2-3m.</p>

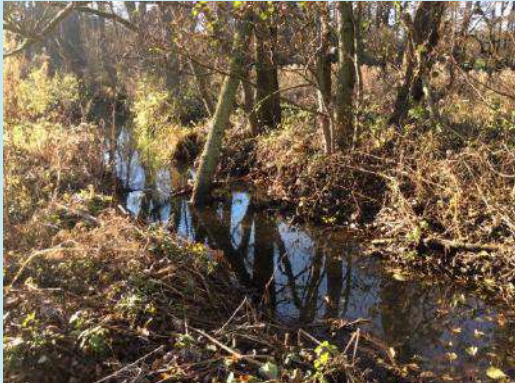
<p>Reach is lined by trees and dense vegetation on both banks. Species-rich fens on left bank.</p>

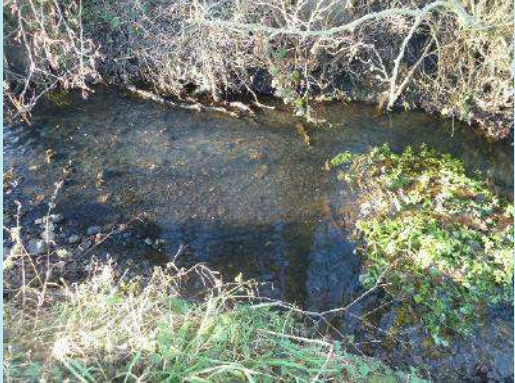
<p>Channel is mostly deep but with some shallower sections, in which the bed substrate appears to be armoured with gravels and sands.</p>

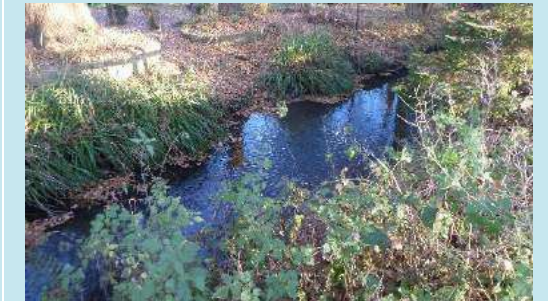
Carex pendula dominant on left bank.

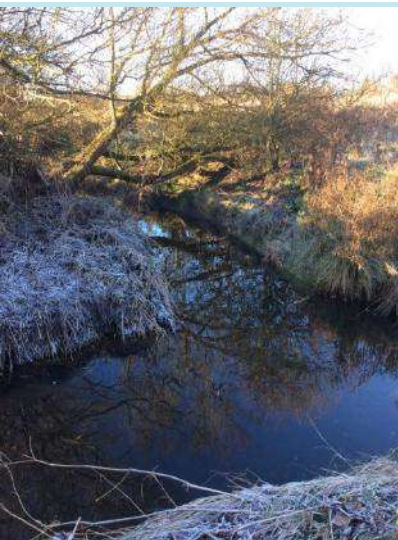
<p>Sharp-right hand bend in channel; over-widened through culvert and access ramp for large machinery.</p>

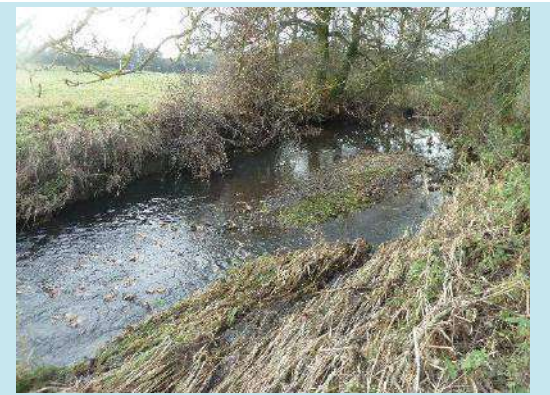
Gravel mid-channel island in the upper reach, with colonising Foo's Water-cress.

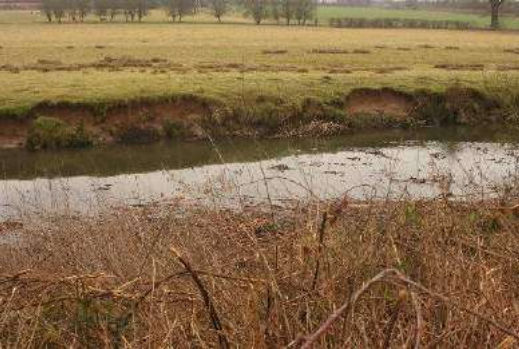
<p>Areas of active bank instability and slumping on straightened reach suffering sheep grazing.</p>

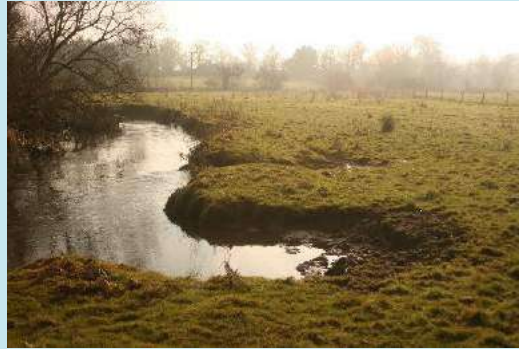
<p>Cattle grazing and watering causing poaching on banks that are not tree-lined.</p>

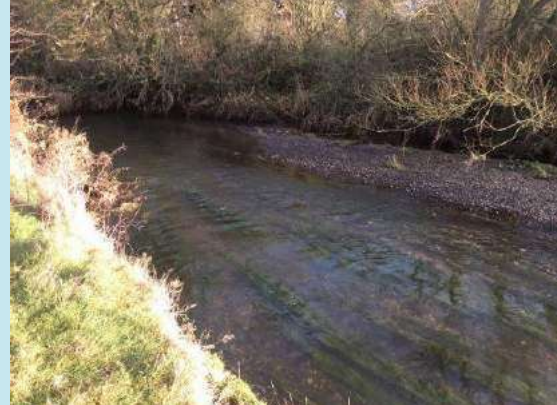
<p>Some small point bars have developed at bends in the channel; these contain small gravels and fines, colonised by Stream Water-crowfoot.</p>

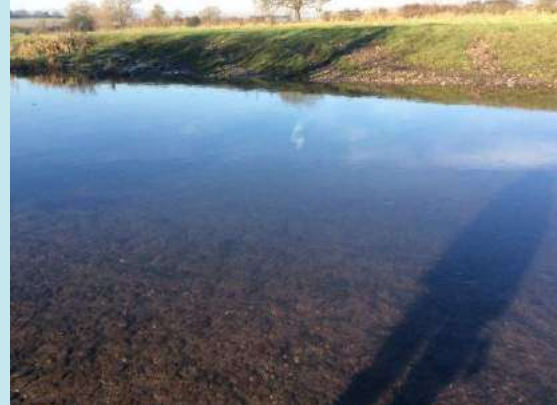
<p>Gravel and sandy bed substrate covered by a layer of fine sediment. Likely originating from local sources; potentially the grazed fields behind.</p>

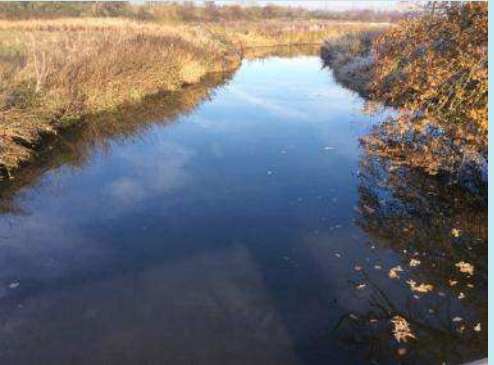
<p>Lone tree on the right bank with open rushy pasture on the left bank.</p>

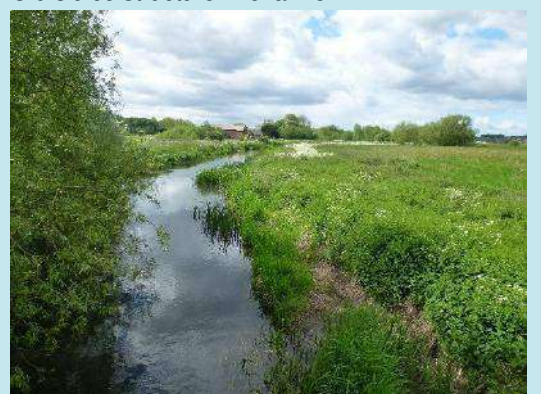
<p>Upstream view of river morphology towards Mill</p>

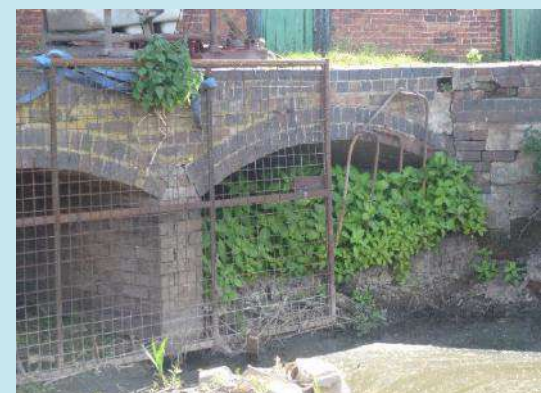
<p>Himalayan Balsam in Mill building</p>

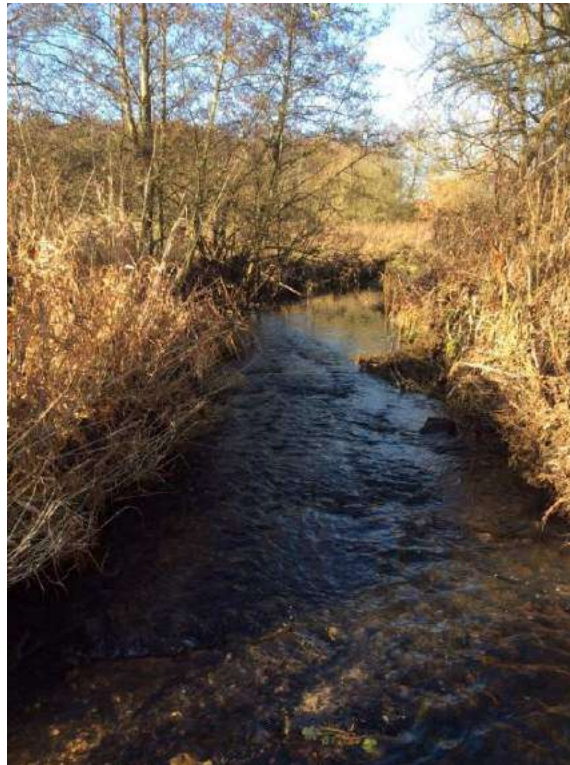
Figure 5-2: Photo example of good connectivity through Shelly Coppice

The presence of large woody material in certain reaches, such as through Coppice Wood, also contributes to better connectivity, by creating localised impoundment. Some reaches are reasonably sinuous and are actively forming vegetated berms through deposition; however, still have a way to go before connectivity is improved.
